Repair and Habitat Restoration for Sustainable Access on
Errigal Mountain,
Co. Donegal

Prepared
for: Donegal County Council

Jan 2019

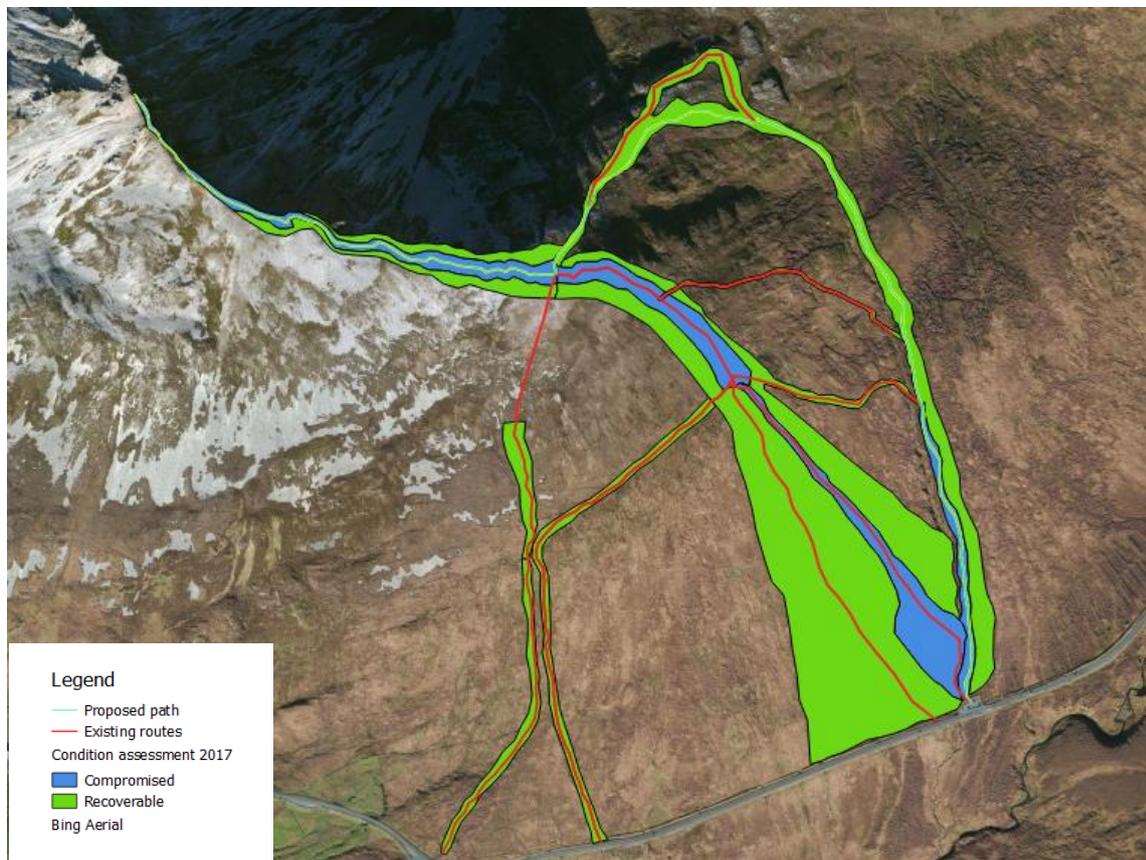
Figure 3: Condition assessment of habitats (carried out in 2017).

Footpath erosion, together with on-going wind and water erosion, is now re-shaping the landscape of the mountain at a rapid rate. A ‘Condition Assessment’ of habitats carried out in 2017 shows the most ‘compromised’ areas used by walkers (Figure 3).

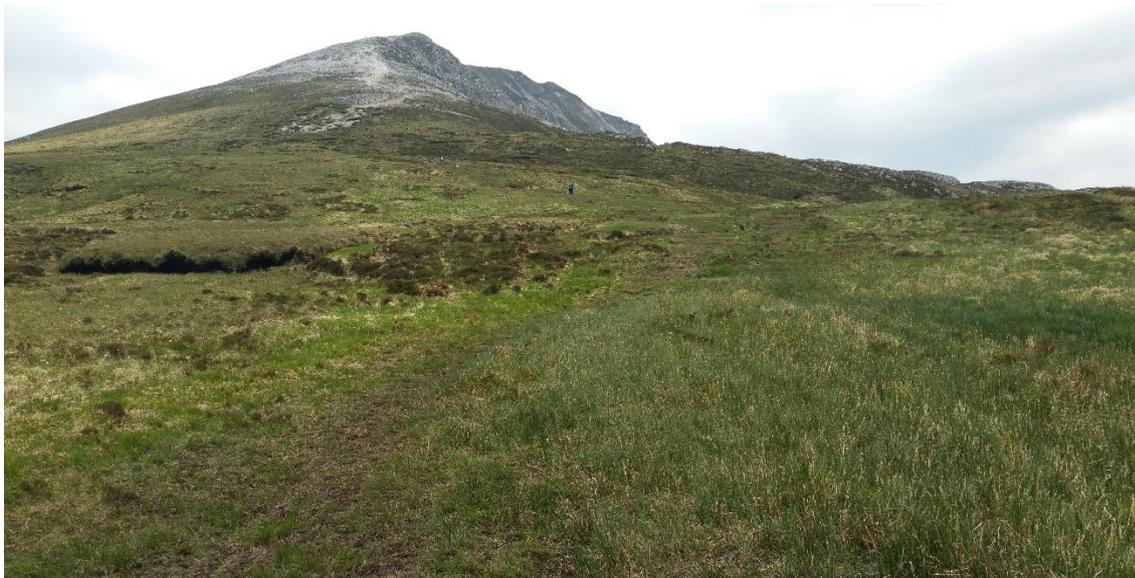
Photo 1: Mid-section of the ‘Direct Approach Route’ likely to natural regenerate (facing north).

- 5 In consultation with NPWS, it is proposed that a chestnut paled fencing will be temporarily installed at judicious locations along the eastern part of the stream in order to restrict passage over the stream to further restrain stray walkers.
- 6 Based on restoration experience gained in other Irish blanket bogs, the removal of trampling alone will likely be successful in the areas that have retained their natural hydrology and where the physical conditions of the bog surface were not irreversibly damaged as a result of combination of peat depth, vegetation, slope and erosion. Photo 1 below shows the middle section of the ‘Direct Approach’ route which includes relatively deep peat area and robust vegetation and where recovery will likely be successful once trampling is removed.

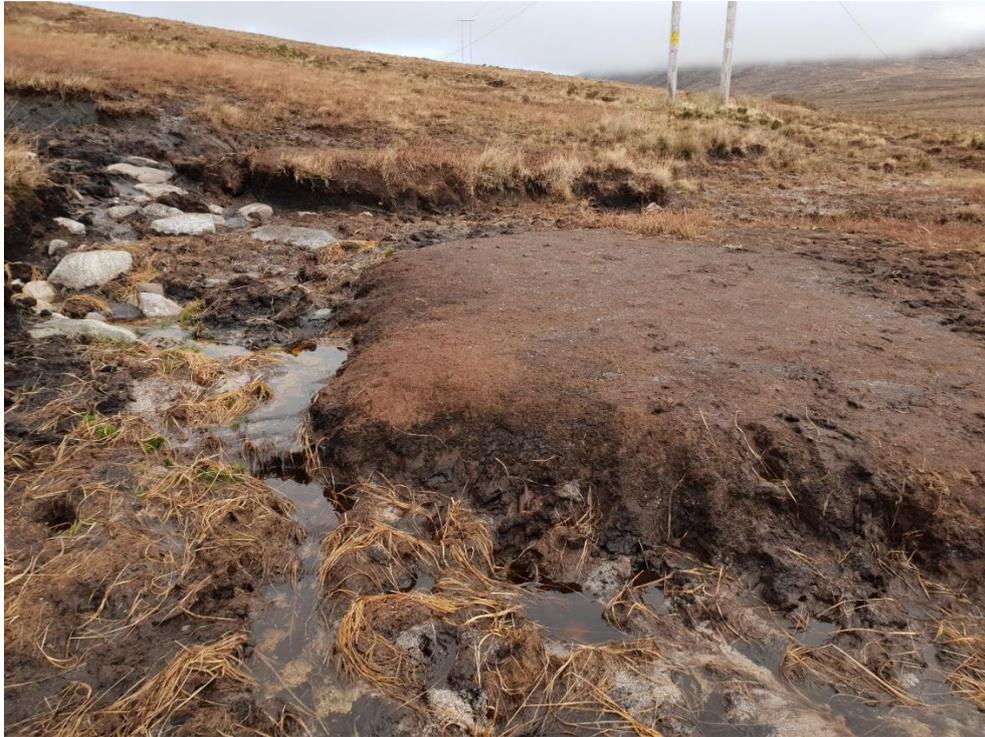
- 7 However, some patches or sections along the ‘Direct Approach’ on the western side of the stream have suffered extreme degradation. Photo 2 below shows an extremely degraded part of the bog where all vegetation has been removed and the peat mass is now compacted and hydrologically isolated. It is proposed to first monitor geo-referenced quadrats within these several damaged areas over the course of two years following the path construction. Initially, peat sods may be strategically placed to dam eroded gullies that are carrying fine sediments from the sub-peat mineral soil. Further planting with heather may be recommended in the bare peat hags to help the colonisation of vegetation by removing wind erosion effect. No further management will be implemented until further assessment of recovery is carried out. It should be noted that there will be **no** use of artificial or natural fertiliser under any circumstances.

**Photo 2: Lower area, near car park on the 'Direct Approach' route. December 2018.
Facing east.**

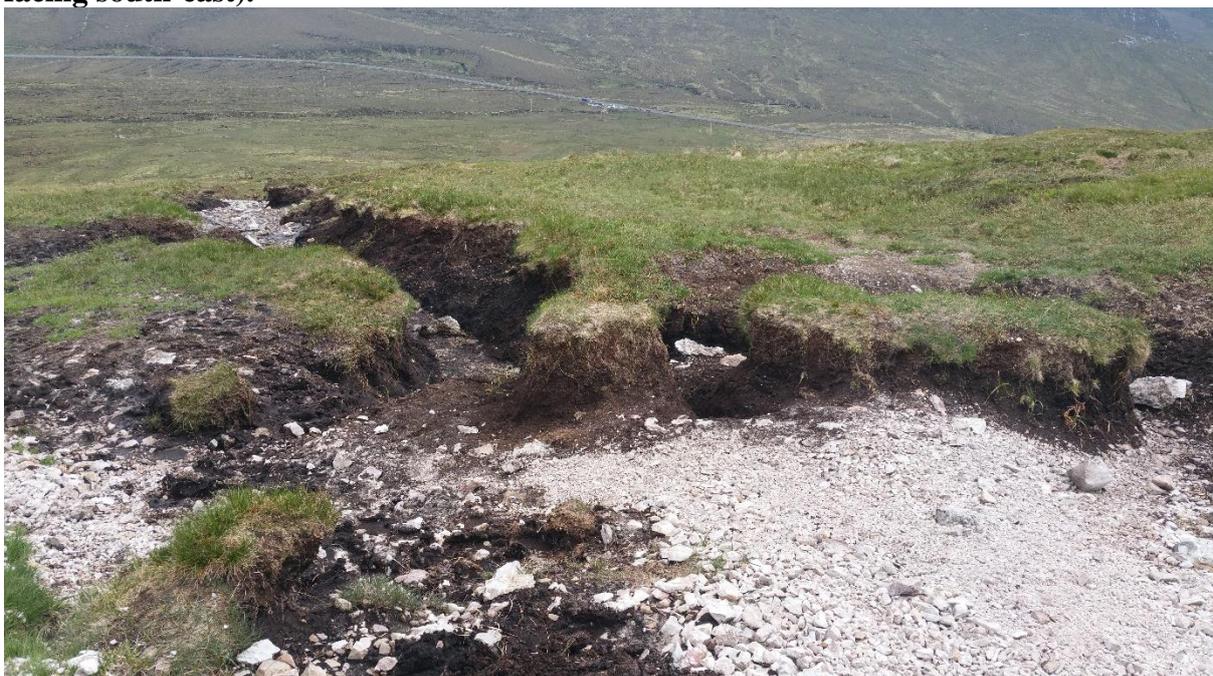
8 Further up on the steeper grounds, the peat is thinner and thus more sensitive to degradation exposing sub-peat mineral soils and aggregate material. In some cases, a gully has formed exposing large aggregate material that are sensitive to physical disturbance (by walkers' boots or major rainfall events) (see Photos 3&4 below).

Photos 3: Upper section of the peat area showing large gully erosion (direct approach, facing south-east).

In terms of habitat restoration, these areas are extremely problematic and, while the exclusion of hill walkers will help recovery by stabilising the aggregate and the remaining soil, the recolonisation by vegetation will be very slow. It is proposed to monitor geo-reference quadrats to appraise the development of vegetation. Some aggregates that have been kicked further down may be brought back up to slow the runoff of surface water through large gullies, creating small dams that will help the recovery of bog-specific vegetation.

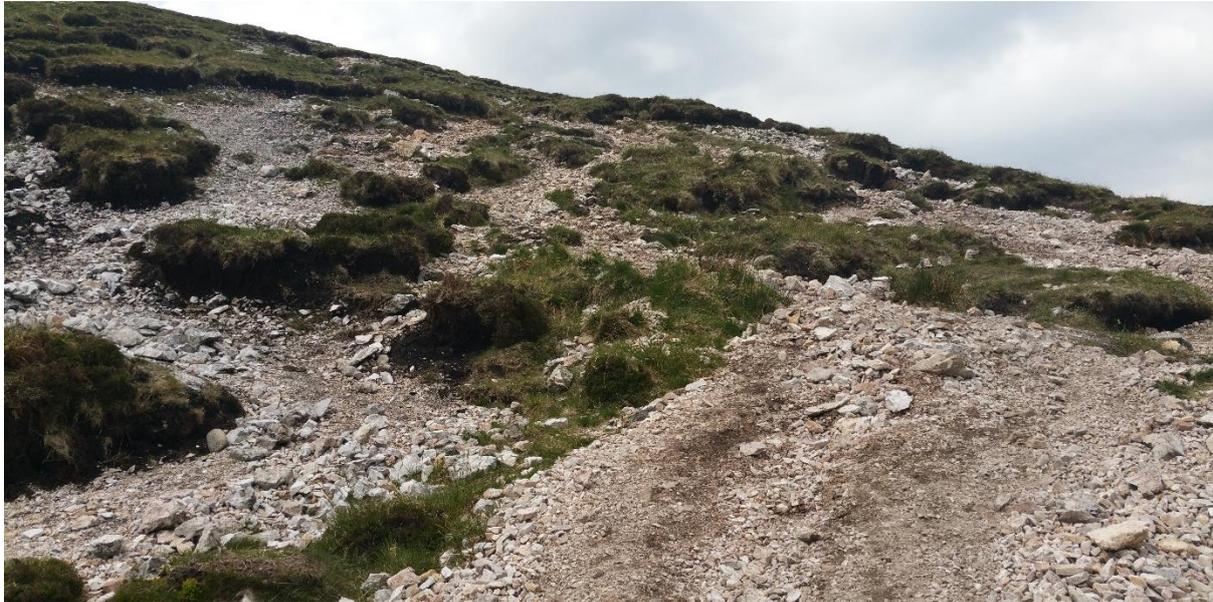
Photos 4: Steeper section of the peat area showing large gully erosion (direct approach, facing north).

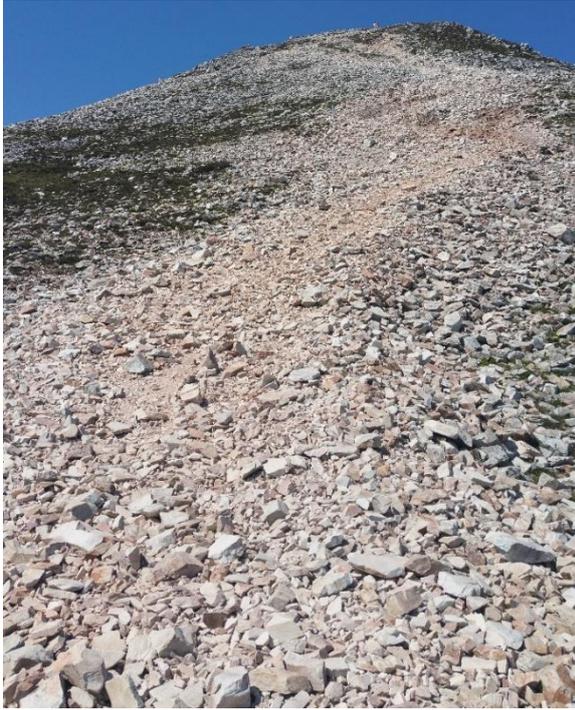
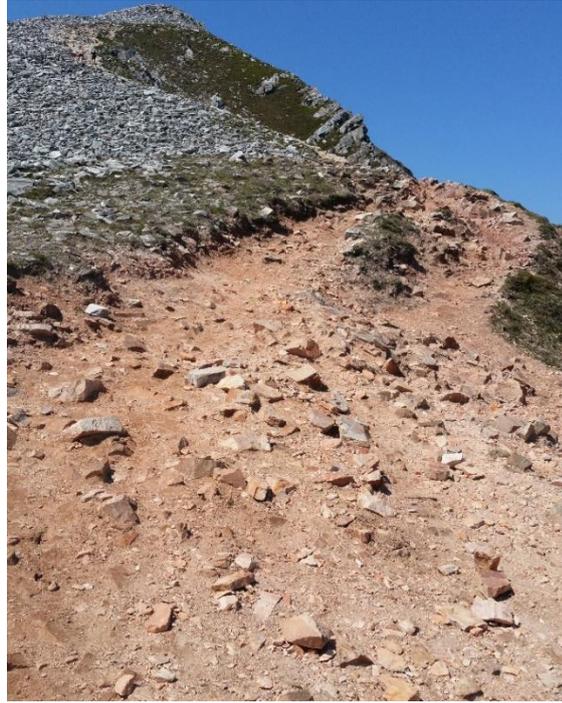
9 The stony, steep slope (see Photos 5&6 below) has very thin soil and short vegetation, if any, in the vicinity of the current route. This section will require little action since the path will follow the worse affected areas. Vegetation will slowly recolonise where possible as the walkers are restricted to the new constructed path, thus preventing the further movement of aggregates down the slope.

Photos 5&6: Steep ridge facing west on the steepest part of the climb (main ridge facing north).

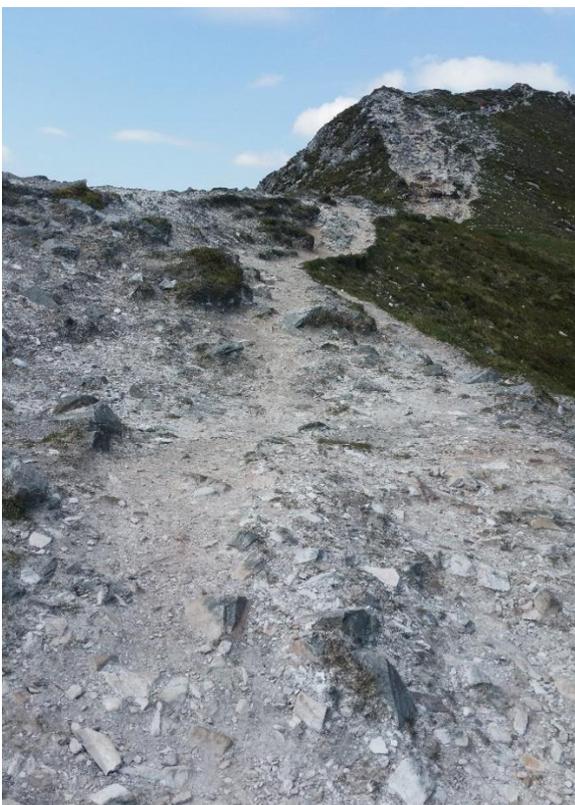
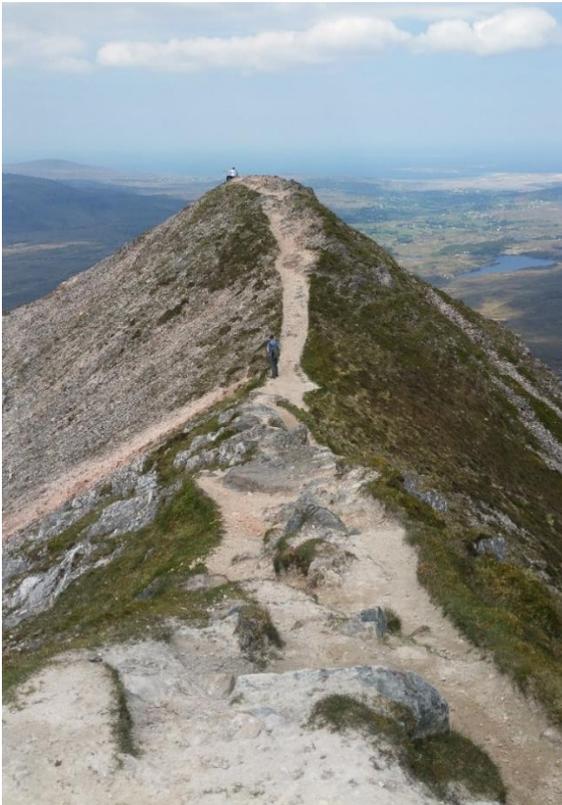
10 Finally, the flat ridge near the summit of Errigal has currently a very narrow path, which will also form part of the new proposed path (see Photos 7&8 below). On either side, the Alpine and Boreal heaths, which occur there naturally, are mostly intact and will remain unaffected. However, monitoring is also prescribed for this section to appraise the effect of the path construction.

Photos 7&8: Main ridge near the summit of Errigal (facing north).

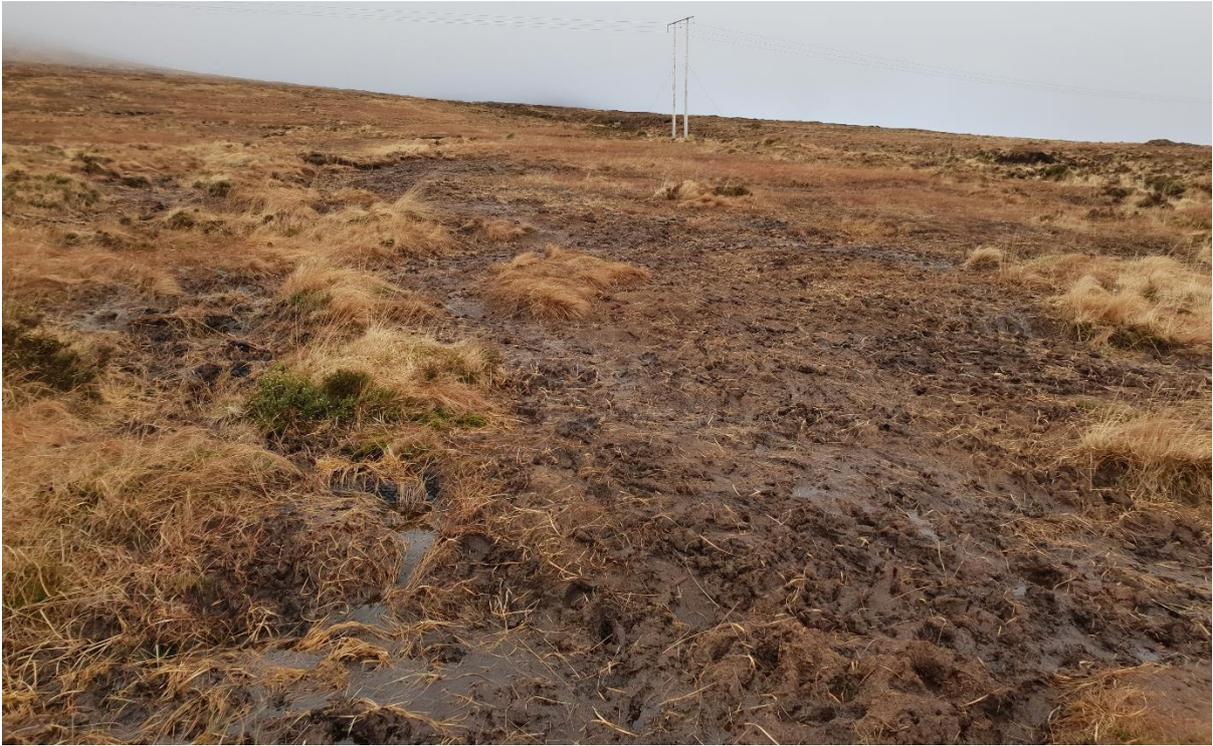
Lower area, near care park, left of stream. December 2018. Facing north.

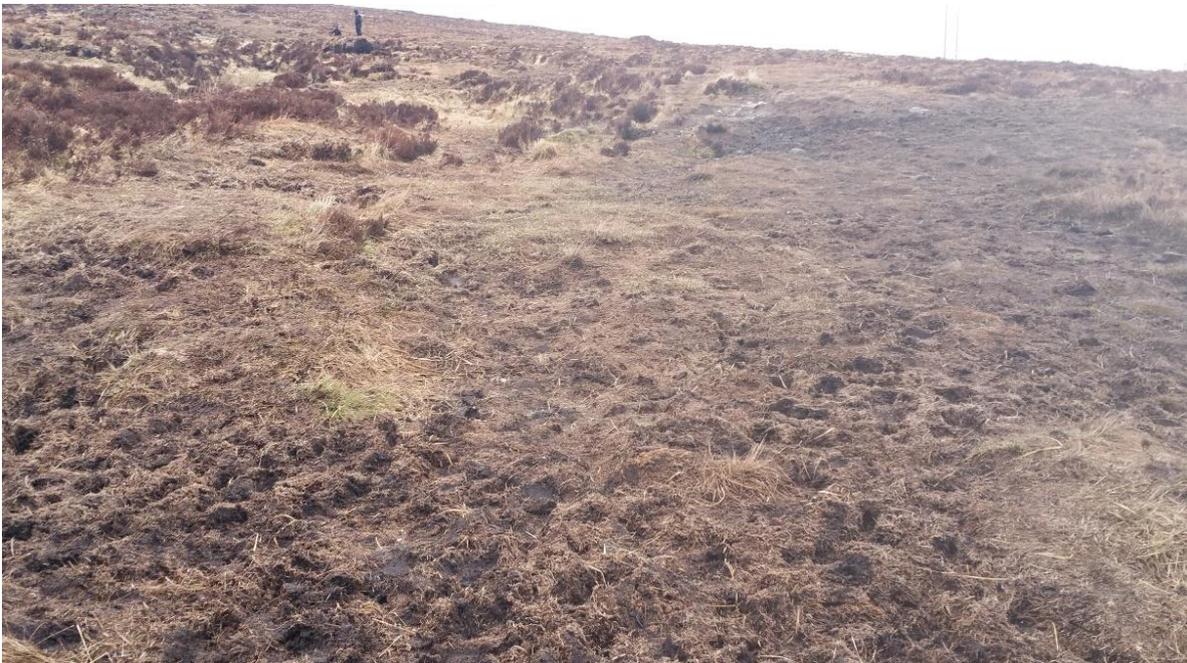
Lower area, near car park, right of stream. March 2018 (facing west)

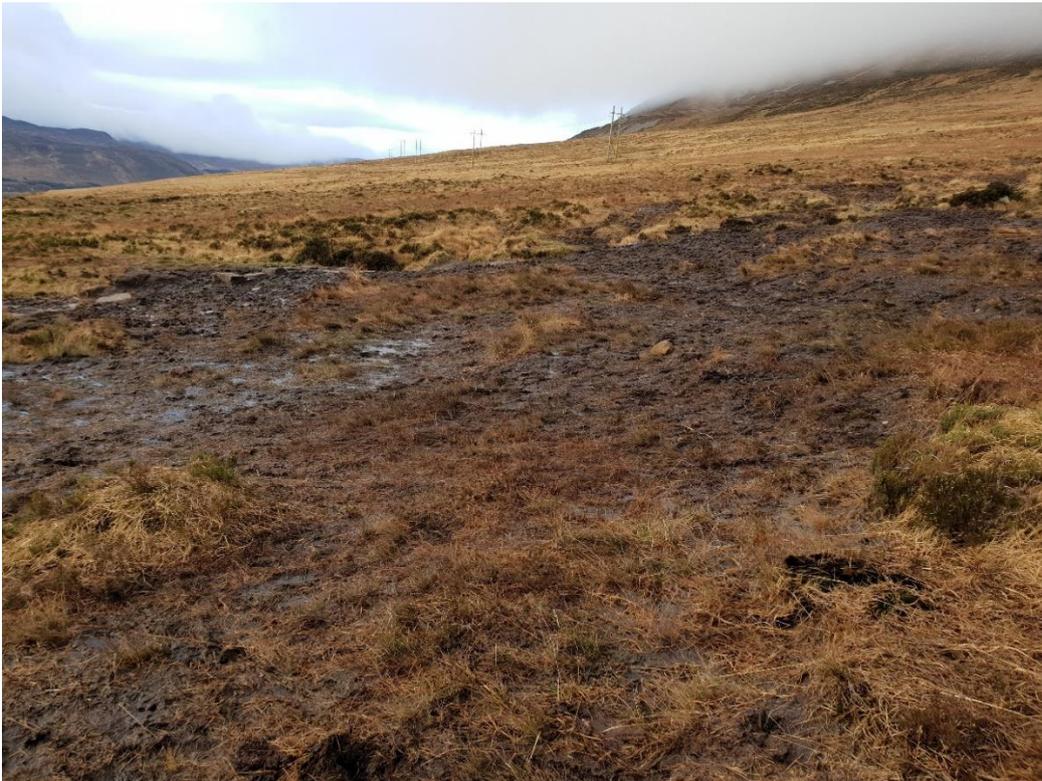
Lower area, near car park, right of stream. December 2018 (facing west)

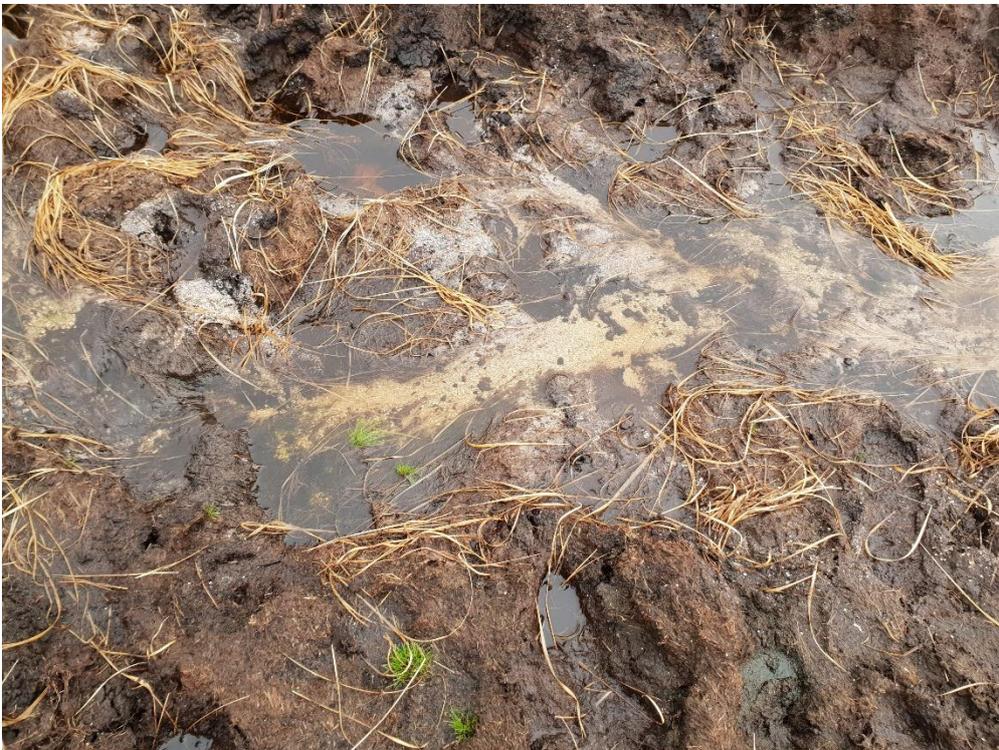
Gully developing following severe erosion of the peat in the lower slopes of the route (west of stream; near car park).

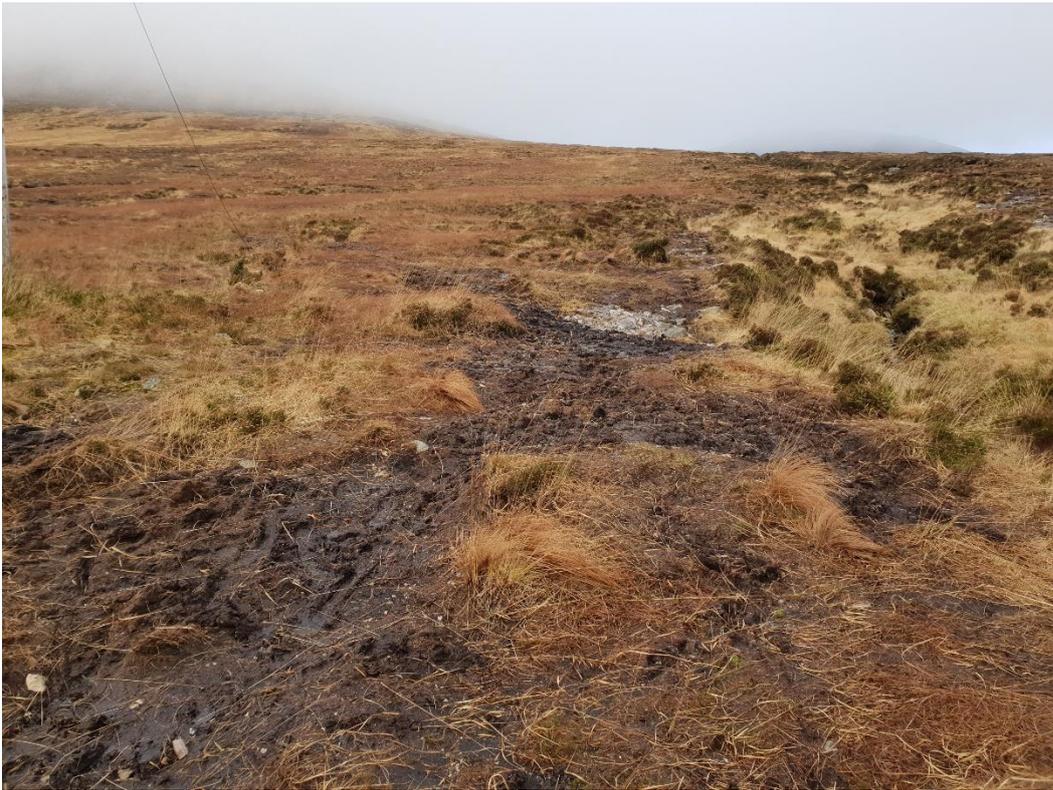
Lower area, left of the stream. December 2018, (facing north).

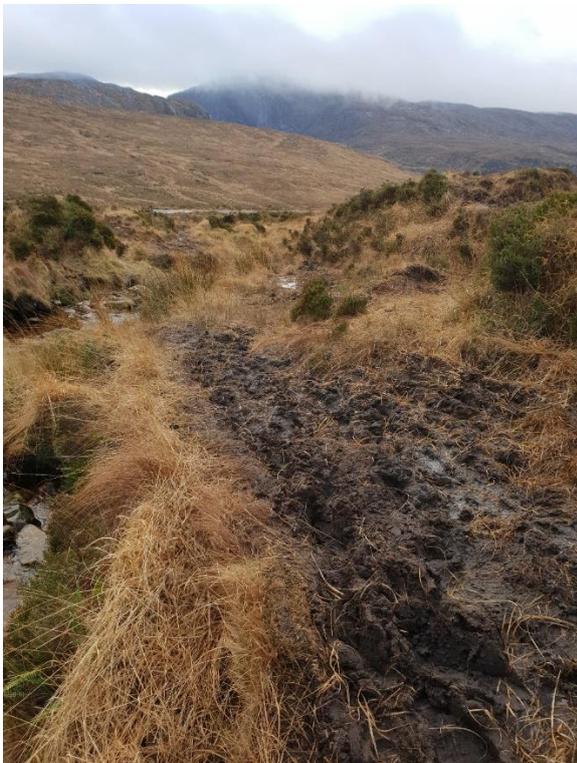
Trampled area on the bank of the stream near car park (facing south).

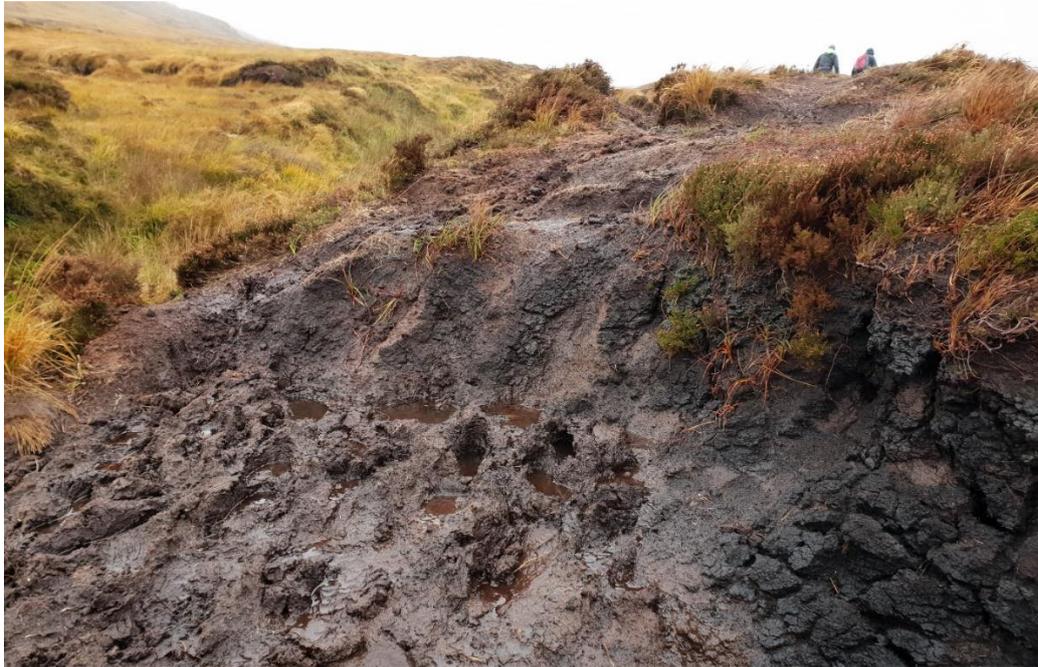
Deep peat section showing damage of walkers climbing peat hags and leading to further erosion by water. Right of stream. October 2018. Facing north.

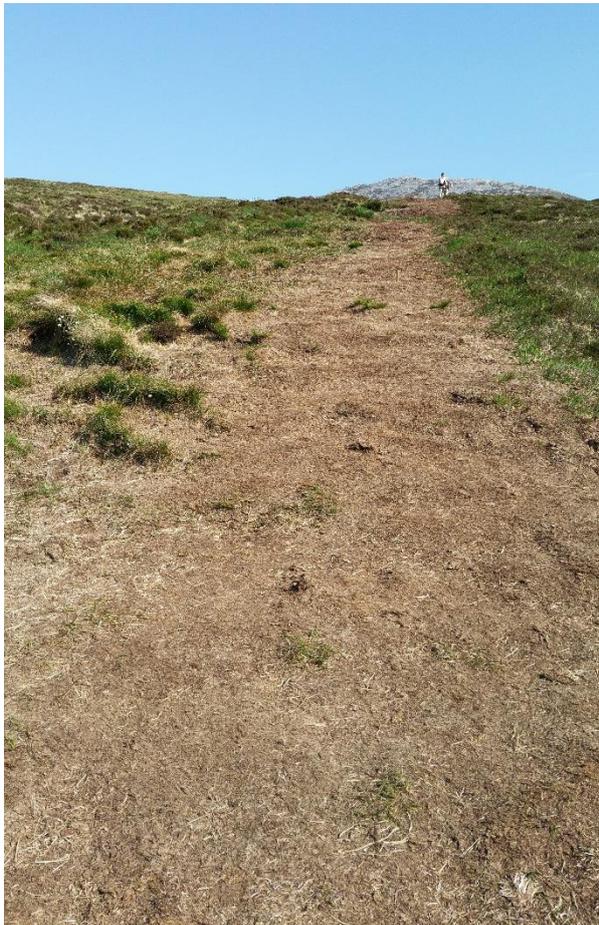
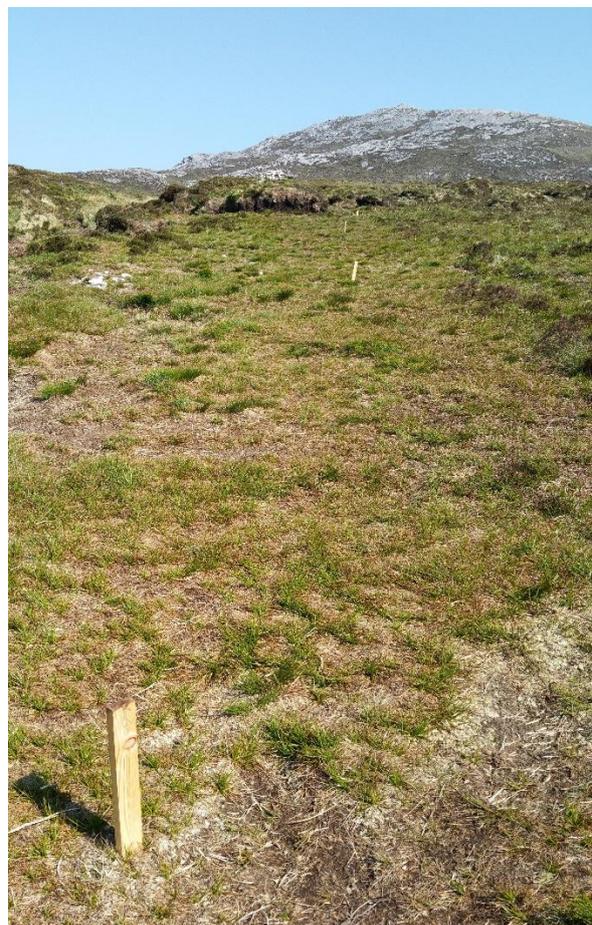
Existing path right of stream (facing north)

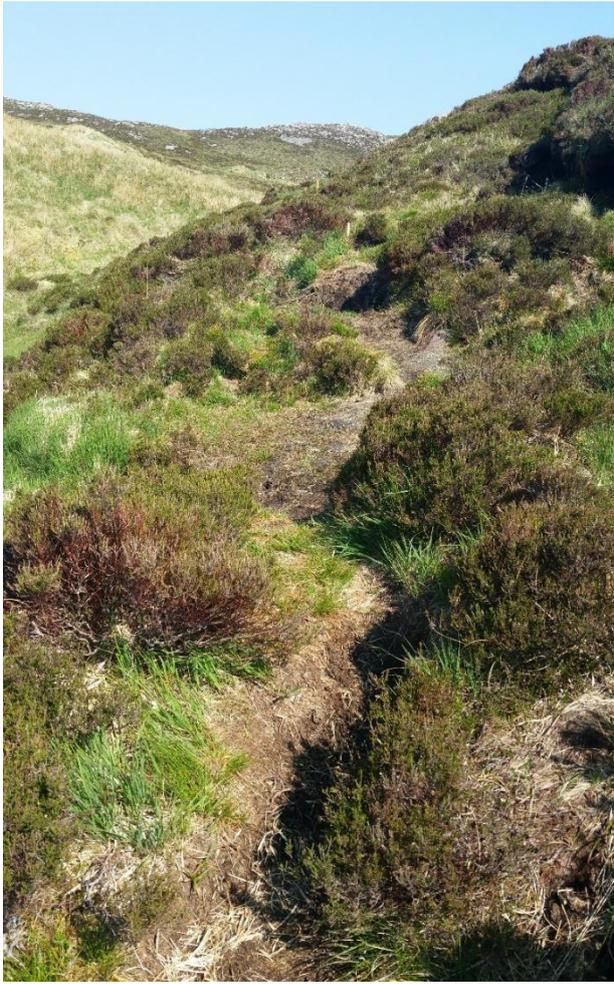
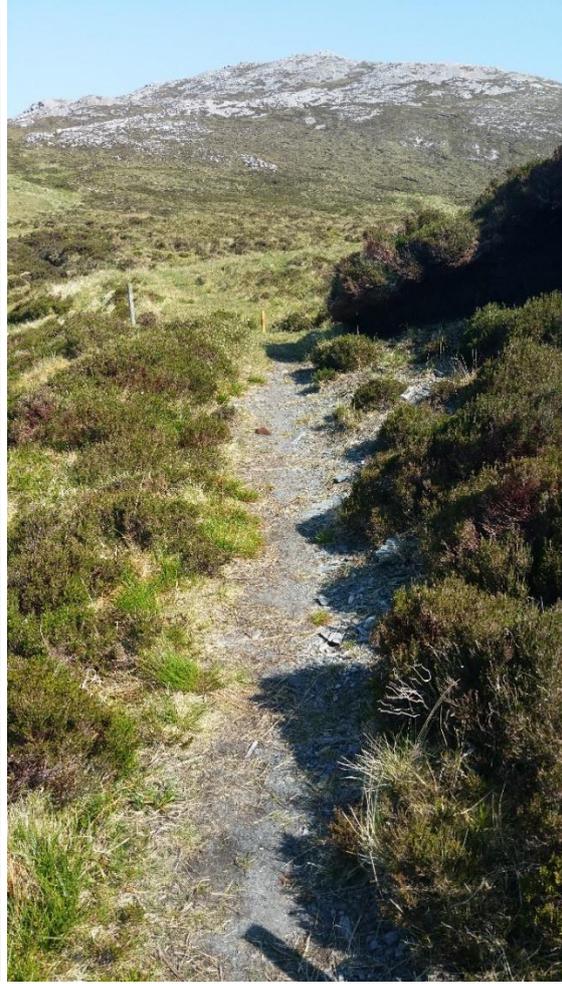
Existing parth right of stream mid-section (facing north)
