**Comhairle Contae  
Dhún na nGall**  
Donegal County Council

**SECTION 1d) DONEGAL MUNICIPAL  
DISTRICT- REMAINDER OF ADDITIONS  
made at the Donegal Municipal District Meeting on  
30<sup>th</sup> June 2017.**

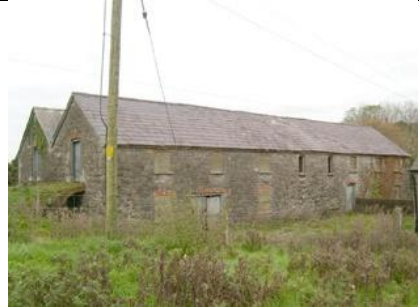
Reference Number	Type of Structure	Photo	Name	Location	Description	Appraisal	Special Interest	Rating
40850001	Mill

Pettigo Corn and Saw Mill	Ardnaglass, Pettigoe	Complex of former corn and saw mill buildings, built c. 1820 and extended in 1851, comprising main eight-bay two- and storey building to building to the north and three-bay three-storey building to the south. Later also in use as a power generation station c. 1930 - 1962. Now out of use. Possibly incorporating fabric from earlier corn mill to site in existence in 1756. Brick and stone bridge over basement level to north-east elevation of main building, giving access to entrances to upper storey. Cut stone and brick bridge over basement level to three-storey building to the south. Remains of iron mill wheel with timber paddles and associated machinery to south-east corner of main building; mill wheel set in wheel pit with rubble stone retaining walls. Pitched natural slate roofs with clay ridge tile, projecting stone eaves courses, and some remaining sections of cast-iron rainwater goods. Coursed squared rubble stone walls having flush ashlar block-and-start quoins to the corners. Shallow segmental-headed windows having stone sills, red brick voussoirs and with remains of multi-pane timber sliding sash windows. Segmental-headed door openings having red brick voussoirs and remains of timber sheeted doors and double-	This substantial former mill complex retains its early form and character despite being out of use for a number of decades. It is well-built using local rubble stone construction with good quality cut stone quoins to the corners, and its continued survival in good condition is testament to the quality of its original construction. Its integrity is enhanced by the retention of much of its early fabric, including timber sliding sash windows and natural slate roof, while the survival of some of the early machine provides an insight into past industrial processes and adds industrial archaeological merit to this interesting site. The contrast between the grey dimension stone and the red brick detailing creates some visual interest to the elevations of these functional utilitarian buildings. This mill complex is of social historical interest to the local community as a significant employer during the nineteenth-century. A possibly terrace of former mill worker's houses (not in survey) stands a short distance to the south-west of this complex. These buildings form a pair of related sites with the structure adjacent to the south-west (see 40850002), and are an important element of the built	Architectural, Historical, Technical	Regional

Reference Number	Type of Structure	Photo	Name	Location	Description	Appraisal	Special Interest	Rating
					doors. Cut stone surrounds and cut stone plinth blocks to a number of doorways. Set back from road in extensive grounds on the west bank of the Termon River. Site slopes from the west to the east towards the river. Located to the north of Pettigoe. Rubble stone walls and remains of buildings, now demolished, to site. Remains of former weir to the north-east of complex. Former offices (see 40850002 located adjacent to the south-west. Rubble stone boundary wall with rounded rock-faced coping over to road-frontage to the west and south-west. Gateways to the north and south ends of boundary wall comprising a pair of ashlar stone gate piers (on square-plan) having cut stone coping over with stone ball finials; wrought-iron flat bar gates.	heritage and social history of the Pettigoe area. The boundary walls and the good-quality gateways, and the remains of the weir to the north-east, complete the context and add considerably to the setting. This mill was built by the Leslie family, the local landlords and proprietors of Pettigoe and surrounding areas from the mid-seventeenth to the mid-twentieth century. It is likely that the town of Pettigoe developed where it has on account of the mill and the waterpower potential of the Termon River. Apparently this mill at Pettigoe could operate all year round, which is unusual, due to a system of sluices established at three small lakes up stream (namely Lough Naeague, Lough Navarnog, and Lough Veenagreen) that were used to supply the supply of water into the river during dry periods. The exact date of original construction is not know but a mill stood on this site in 1756 and a much smaller corn mill building is indicated on a map of the area in 1836 (Ordnance Survey first edition six-inch map). The Leslie family (Sir John Leslie, 1st Baronet) later built a large flax mill at this site in 1851, possibly incorporating parts of this earlier building. The majority of the

Reference Number	Type of Structure	Photo	Name	Location	Description	Appraisal	Special Interest	Rating
						<p>buildings to site probably date to this period. A saw mill was later established at this site during the late nineteenth century, and timber egg boxes were constructed to site amongst other produces. This mill was also used to generate electricity and it produced enough to power the village of Pettigoe during the 1930s. The mill was later purchased by the ESB in 1957 from the then owner, a Mr Shaw, who generated electricity to site into the 1960s before the mill closed.</p>
