Repair and Habitat Restoration for Sustainable Access on
Errigal Mountain,
Co. Donegal

Prepared
for: Donegal County Council

Jan 2019

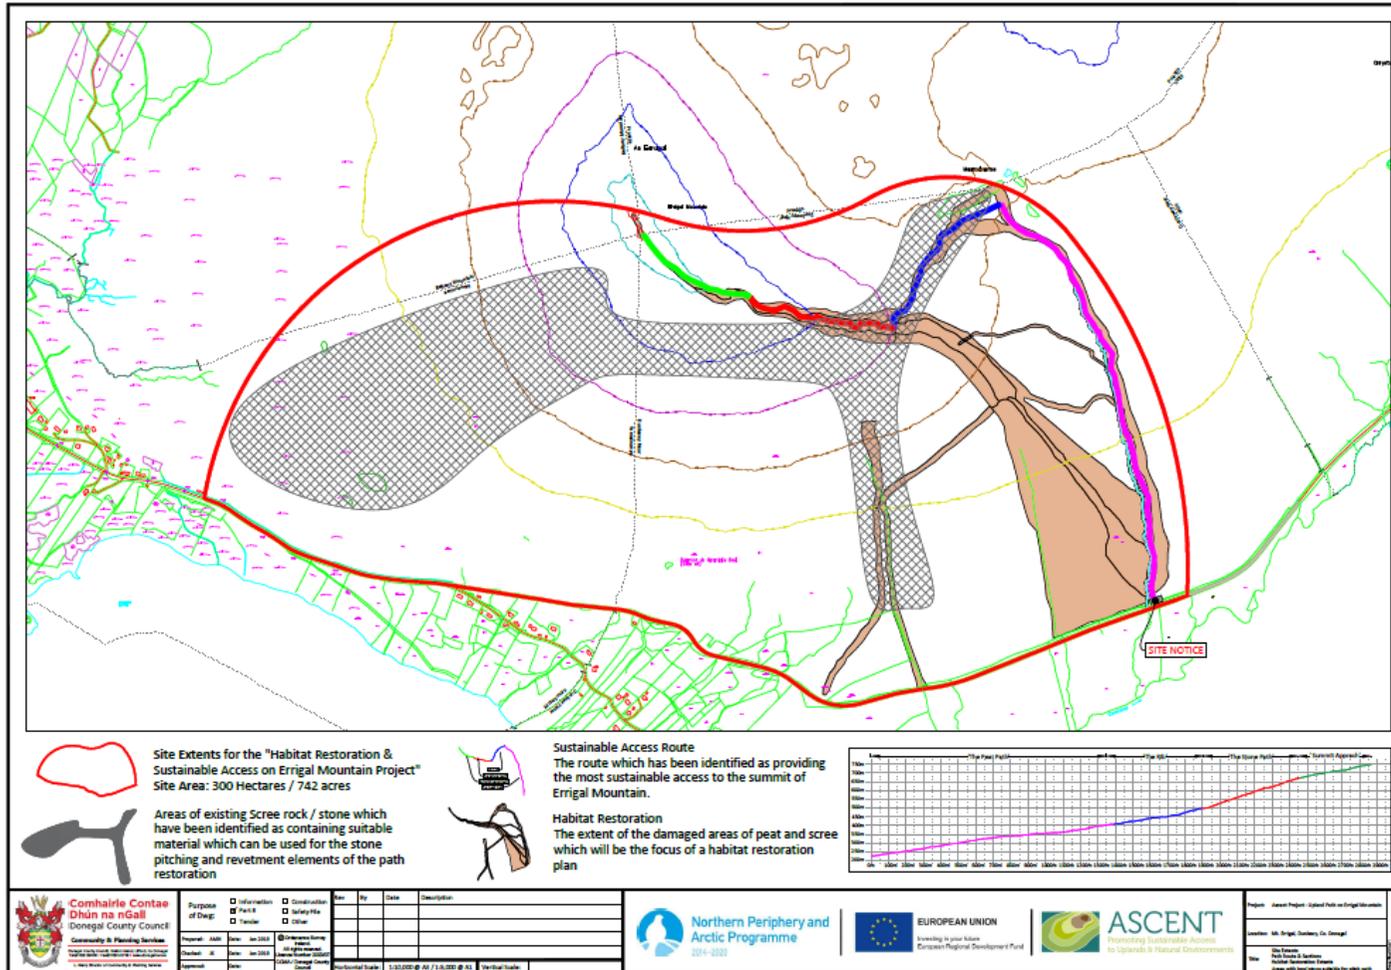
Figure 3: Map showing path sections of the proposed Sustainable Access Route, extent of Habitat Restoration Plan and areas to source boulders.

Footpath erosion, together with on-going wind and water erosion, is now re-shaping the landscape of the mountain at a rapid rate. A ‘Condition Assessment’ of habitats carried out in 2017 shows the most ‘compromised’ areas used by walkers (Figure 3).

- 4 Sourcing of the larger boulder to ‘anchor’ the path will take place in pre-approved locations within the footprint of Errigal Mountain (requirement appropriate Ministerial consent) and will be gathered by hand and transported by helicopter (see proposed areas in Figure 2). This will help the natural regeneration as well as natural landscape features.

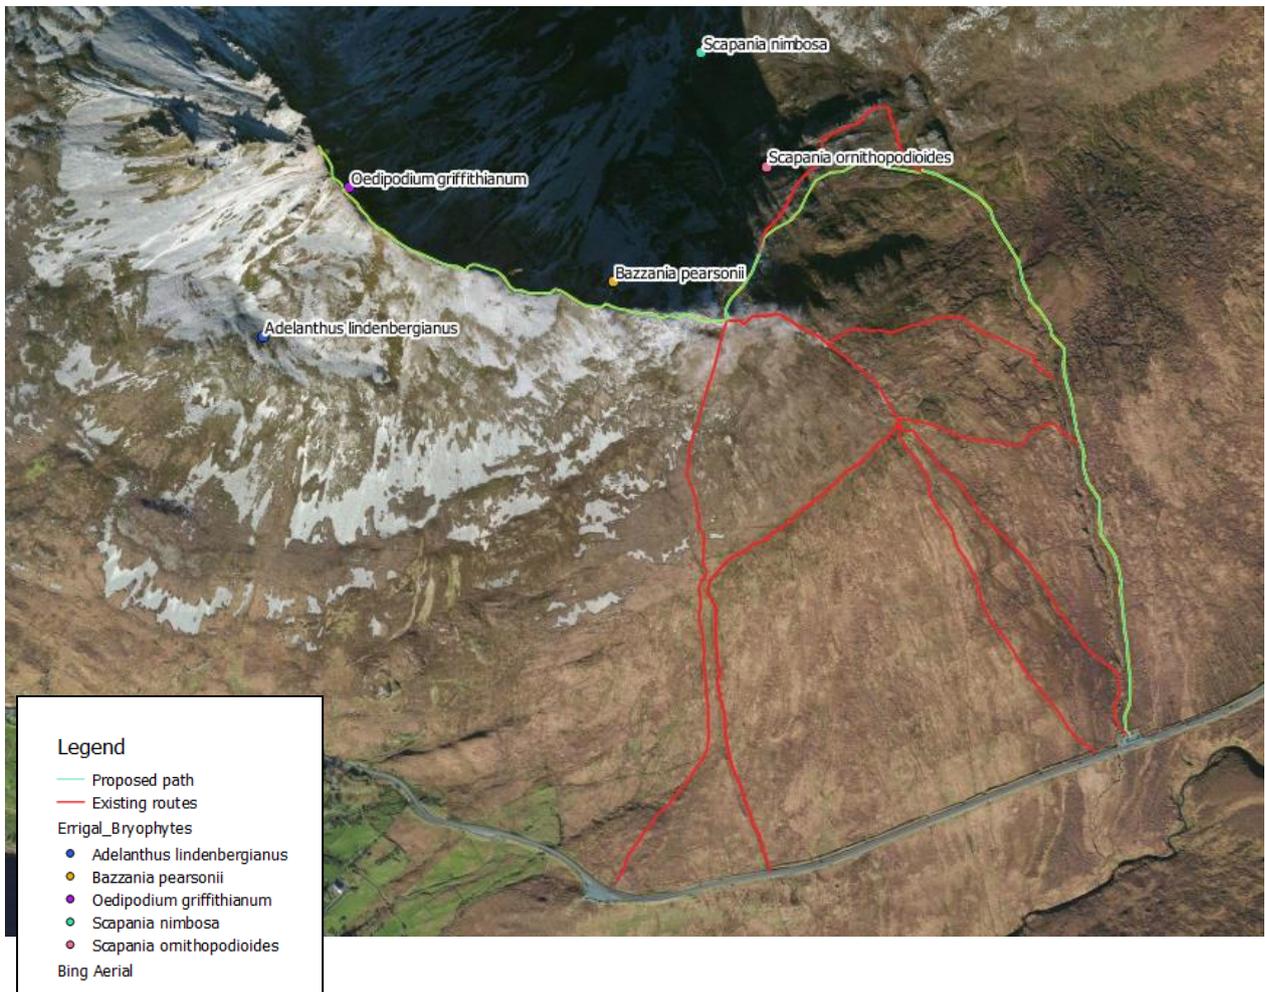
Figure 9: Location of rare species (mosses and liverworts) vis-à-vis project (proposed path in green; used routes in red).

11 Finally, rare species can occur within the mountainous habitats found on Errigal Mountain and rare mosses and liverworts have been recorded within the vicinity of the project (see Figure 9 below map of location). Therefore, care should be taken not to disturb these species that usually occur within hepatic mats (*Calluna vulgaris*-*Herbertus aduncus* community). From the Flora (Protection) Order (updated January 2018), the following four mosses have been identified in the vicinity of the project: *Adelanthus lindenbergianus*, *Scapania nimbosa*, *Bazzania pearsonii* and *Oedipodium griffithianum*. Their locations have been recorded (see map below) and the working corridor will remain outside their vicinity. The moss *Oedipodium griffithianum* (located on the summit of Errigal mountain) is growing on a very steep rocky northeast-facing slope below the summit; the route is located just above. Supervision by a suitable ecologist, together with appropriate methods at this location will be employed to avoid any disturbance to this population. Meanwhile, the proposed path will prevent further damage of the Alpine Heath habitat and by presenting one line will help restore habitat on either side.
